Key Words: DST, ULTRASONIC, INSPECTION, CORROSION, INTEGRITY

ULTRASONIC INSPECTION RESULTS FOR DOUBLE-SHELL TANK 241-AP-106 – FY 2005

RPP-RPT-23205, Rev. 0A

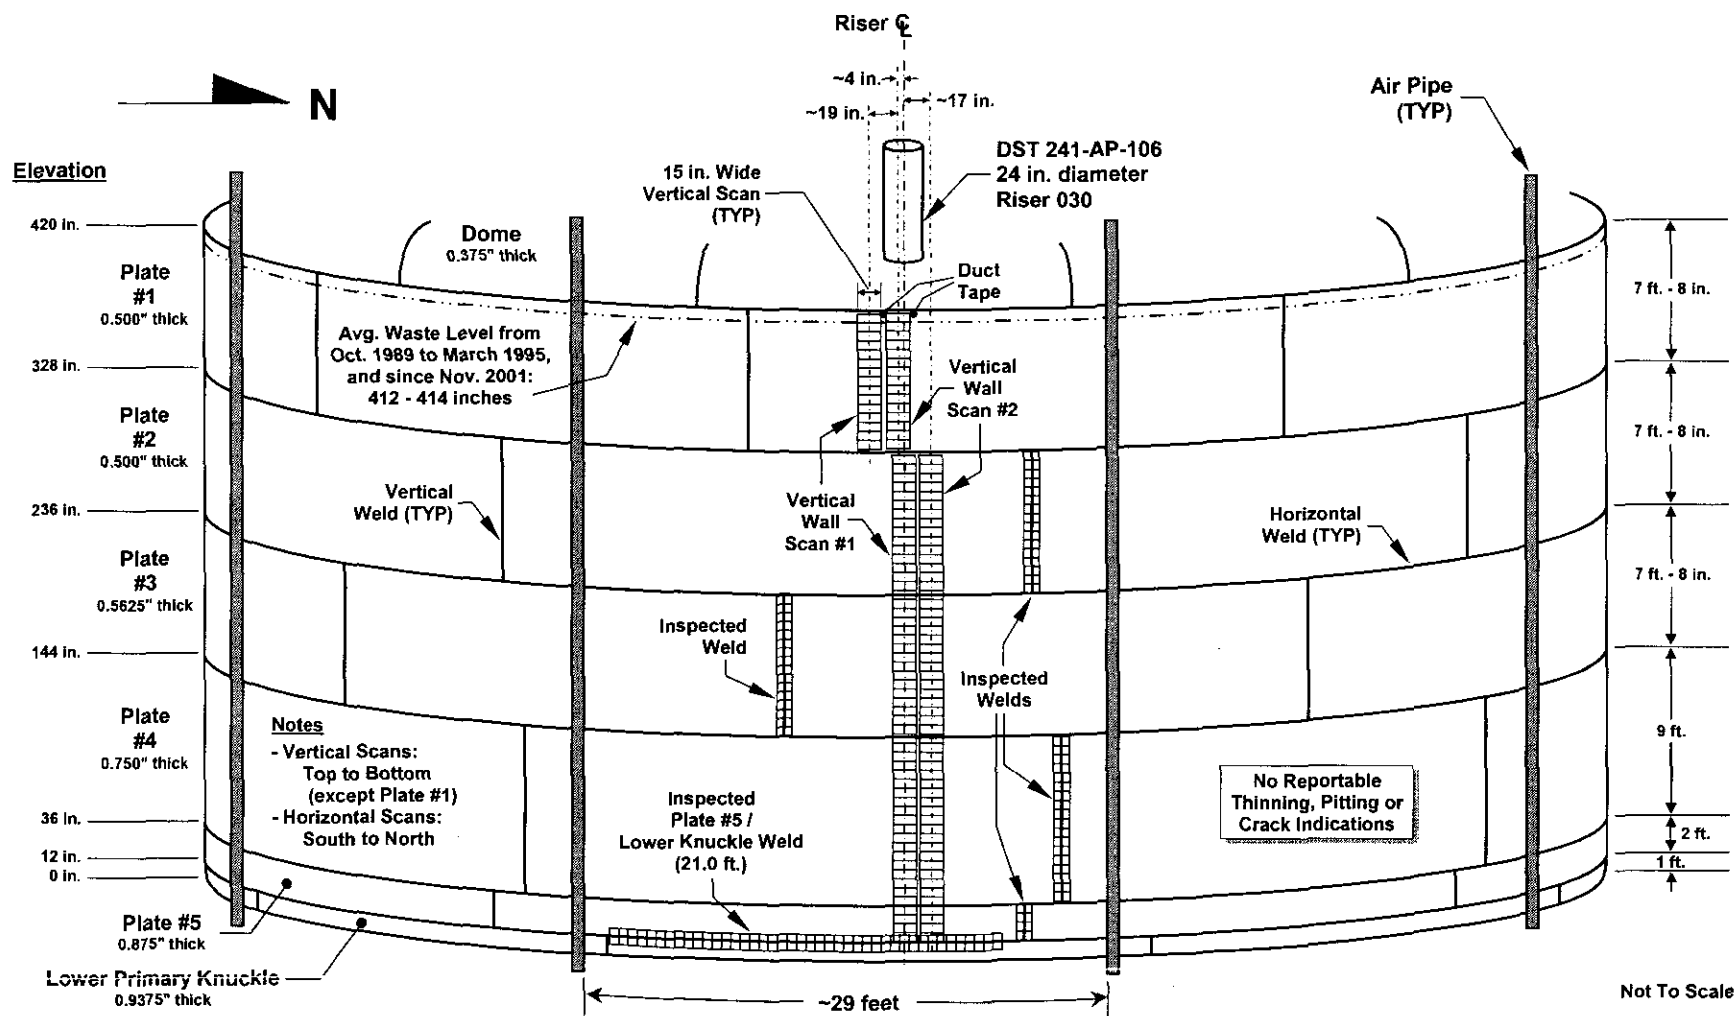
Figure 10-1. Schematic of UT Scan Paths on East Side of Tank 241-AP-106 Wall (via Riser 030)

The P-scan crawler was deployed through the 24 inch diameter annulus inspection Riser 030 at the east side of tank 241-AP-106 for examinations of the primary tank wall, and the vertical and horizontal welds. All tank welds examined were in the “as-welded” condition. The various scan paths for the crawlers are shown in Figure 10-1, along with other pertinent tank information. Note that for Plate #1 only, the vertical wall scans were performed from the plate bottom to the plate top. This was due to the interference of the recently modified crawler cable bracket with the secondary dome if the scans were performed from the customary top to bottom. Both Plate #1 scans were also started at radial locations north of the centerline of the riser rather than at their usual locations (refer to scans for Plates #2 through #5). This was due to the presence of duct tape on the Plate #1 plate that prevented scans at the usual locations.

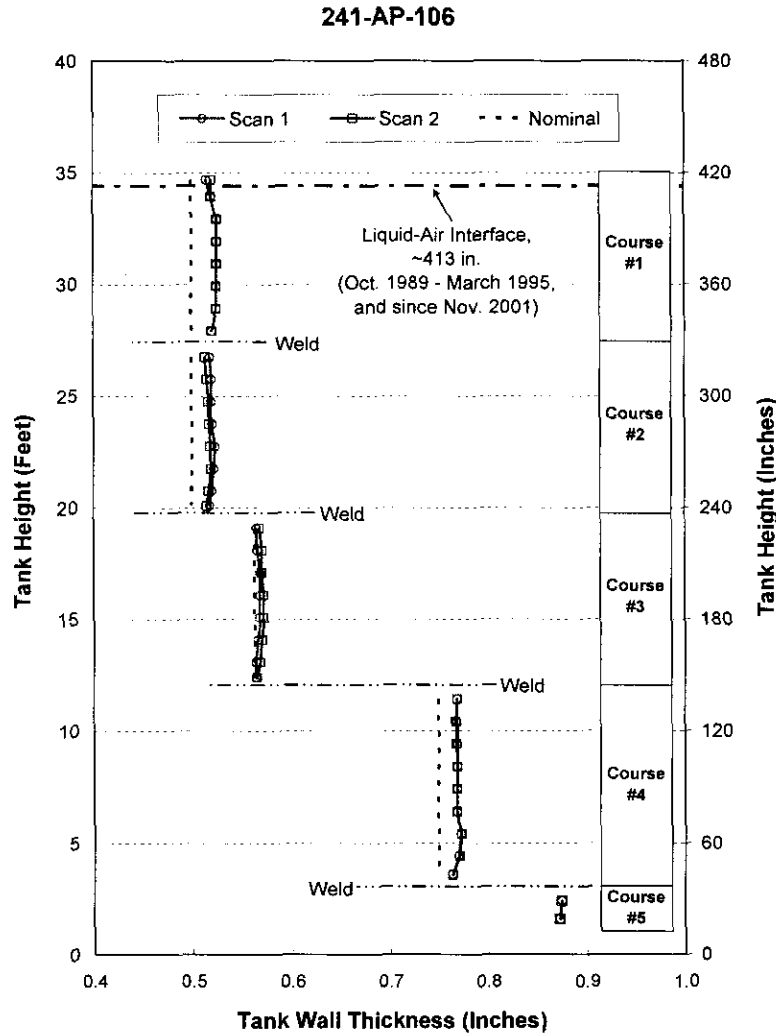
Figure 11-1. Scan Data Average Wall Thickness Compared to Nominal Plate Thickness

The results of the tank 241-AP-106 UT inspections indicated no reportable wall thinning, no pit-like indications, and no cracking in any of the areas examined. Figure 11-1 illustrates all of the "as-found" average wall thickness measurements of the primary tank vertical wall scans generated from the P-scan Inspection Data Sheets (Attachment 2). Each measurement plotted on Figure 11-1 is the average of all data collected over a 12 inch long by 15 inch wide scan area. Areas of interest for tank 241-AP-106 are the vapor space above the current liquid waste, the current liquid-vapor interface (approximately 34.4 feet or 413 inches), and the liquid region.

Primary Tank Wall: Two vertical strips encompassing Plate #1 through Plate #5 were examined. The overall average wall thickness for each plate vertical scan varied only 0.005 inches from plate to plate (for same nominal-thickness plates) and a maximum of only 0.004 inches within the same plate (for all plates). All overall plate wall averages were between 0.001 inches less than to 0.023 inches greater than their nominal plate thickness values. No reportable wall thinning, pitting indications or crack-like indications were found.

Primary Tank Welds: One vertical weld in each of the four Plates #2 through #5 was examined. The plate walls adjacent to the welds averaged 0.013 inches less than (Plate #3) to 0.010 inches greater than (Plate #2) their nominal plate thickness values. No crack-like indications were found. There were also no reportable wall thinning or pitting indications found.

Tank 241-AP-106 did not exhibit any significant thinning. Small degrees of average wall thinning were observed in the 0.5625 inch thick Plate #3 (0.006 inches) and in the 0.875 inch thick Plate #5 (0.012 inches).

- According to a recent Tank Integrity Assessment Project DST Lifecycle Schedule, tank 241-AP-106 is scheduled for its second, standard UT examination in about nine years. Based on the results of this UT examination, it is recommended that this schedule be maintained – there is no reason to perform any near-term follow-up inspections on this tank. Following the second UT examination, inspection parameters such as wall thinning rates can be calculated and used to better quantify and evaluate any continual wall thinning or degradation.
